**OPERATION OF A FORCED CIRCULATION,
CROLOY 9 M, MERCURY LOOP TO STUDY
CORROSION PRODUCT SEPARATION TECHNIQUES**

by D. B. Cooper and E. J. Vargo

Prepared under Contract No. NAS 3-2538 by
THOMPSON RAMO WOOLDRIDGE, INC.
Cleveland, Ohio
for

NATIONAL AERONAUTICS AND SPACE ADMINISTRATION • WASHINGTON, D. C. • APRIL 1965

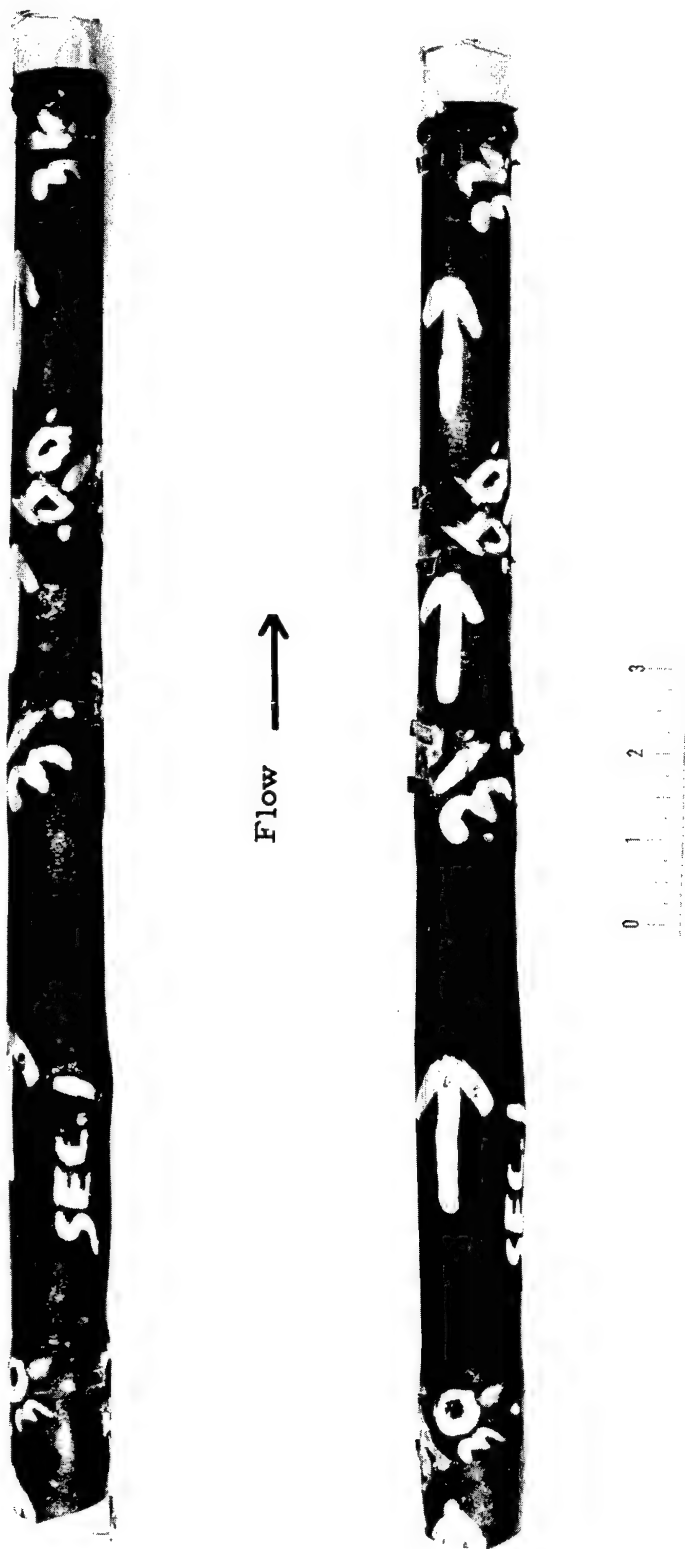
Figure 27 Appearance of the Superheater Outlet Section Showing the Deformation which Occurred.

As stated in a previous section of this report, operation of the loop was suspended 30 hours before scheduled shutdown. The cause of this premature shutdown was the bulging of the superheater outlet tubing by creep resulting in breakage of the heater ribbon.

The wall temperature of this failed portion of the superheater, by excessive creep, was $1405 \pm 10^{\circ}\text{F}$ as indicated and recorded by several thermocouples. At this elevated temperature, the creep strength of Croloy 9M is practically nil; stress to cause 0.001% per hour creep is less than 1500 psi. Since the available strength of the Croloy 9M was thus practically zero, the hoop stress for the superheater outlet section was calculated based only on the Type 316 SS clad portion of the tube and mercury vapor pressure of 269 psia. A value of 1965 psi hoop stress was obtained which is substantially lower than the reported 0.0001% per hour creep strength of 4000-5000 psi.^(6, 7) Since the hoop stress was not excessive for this austenitic steel, the reported temperatures were reviewed for possible error. Since three thermocouples reported $1405 \pm 10^{\circ}\text{F}$ and since the Type 316 SS did not have oxide scale, there was no reason to doubt the reported temperature. However, the observed metallurgical changes in the Type 316 SS mentioned above may be the cause of the accelerated creep and thus could be the primary cause of failure of the tubing. Obviously, the cause of the creep failure of the duplex tubing in the superheater outlet section cannot be determined without further mechanical testing.

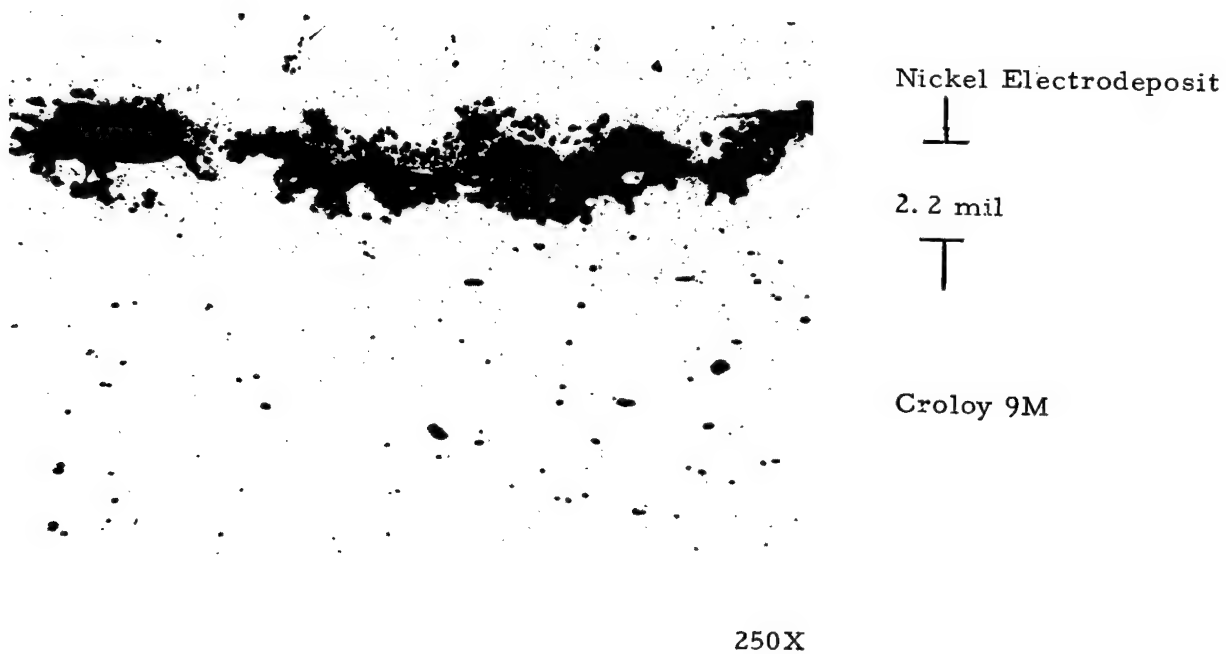
Figure 31. Intergranular Corrosion of Boiler Midsection.
Unetched

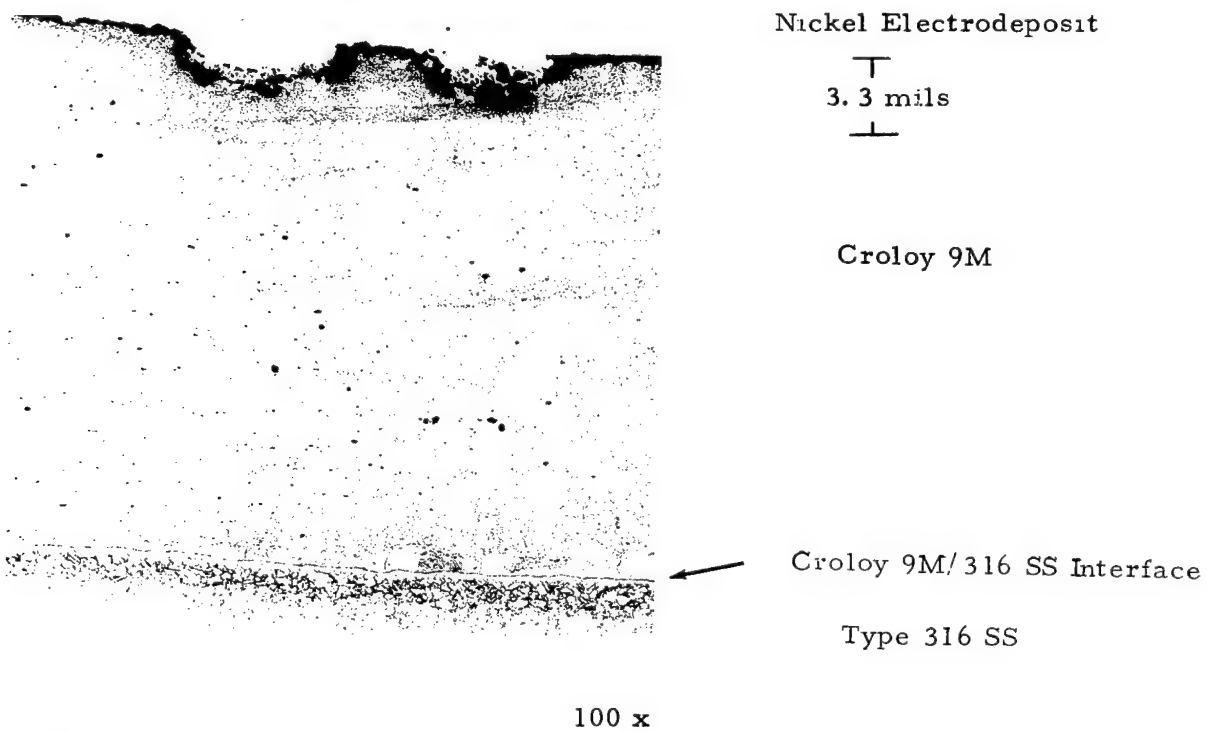
Figure 32. Intergranular Corrosion of Boiler Midsection.
Etchant - Carapella

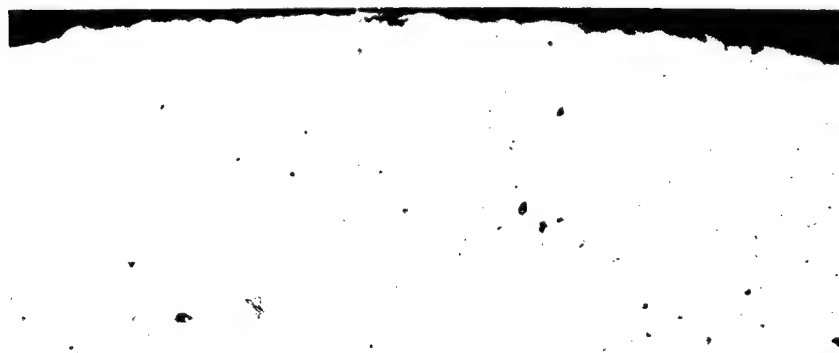
f) Crevice Corrosion of Swirl Wire at Superheater Outlet

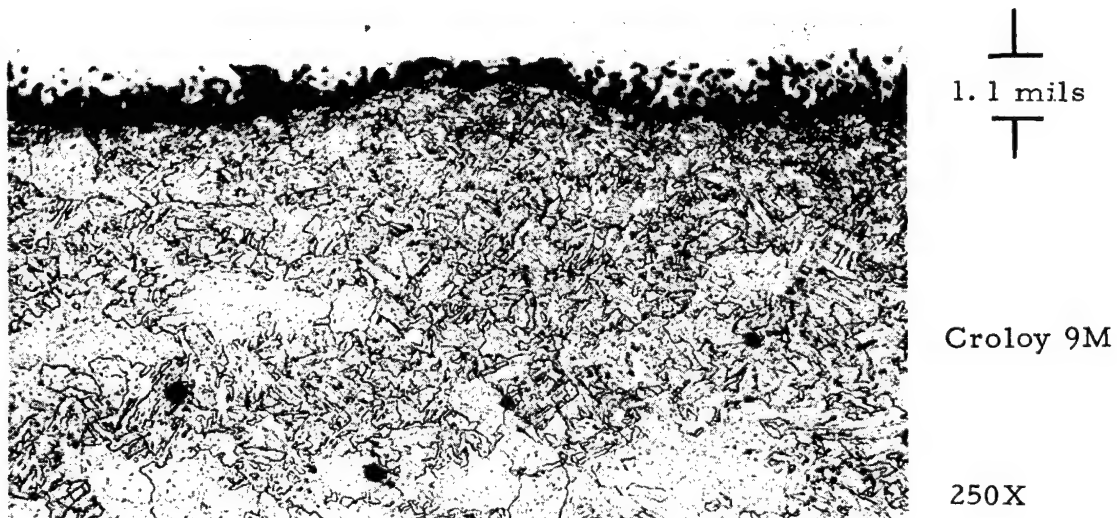
Figure 34. Intergranular Corrosive Attack of Boiler Wall Near Outlet.

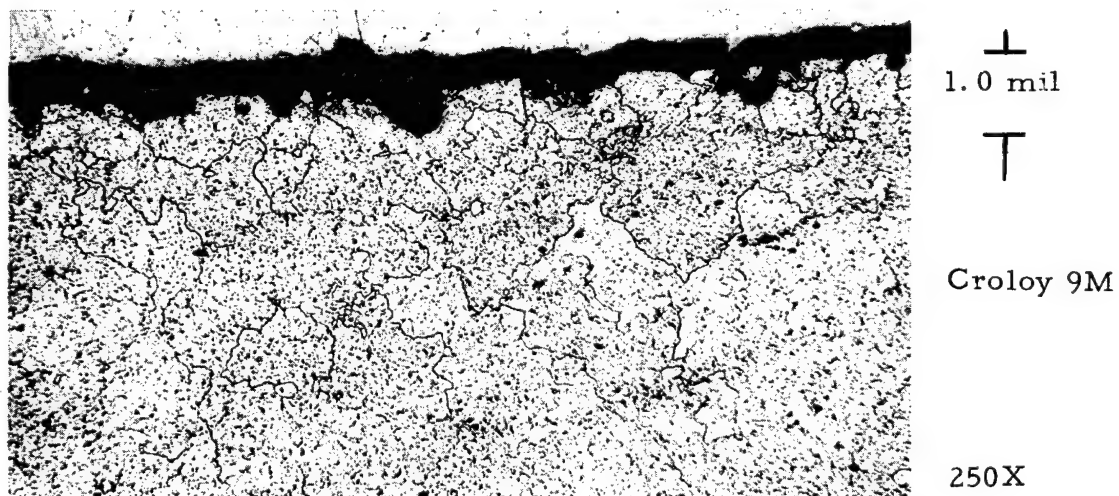
Figure 35. Typical Intergranular Corrosion of Croloy 9M at Inlet to Superheater.

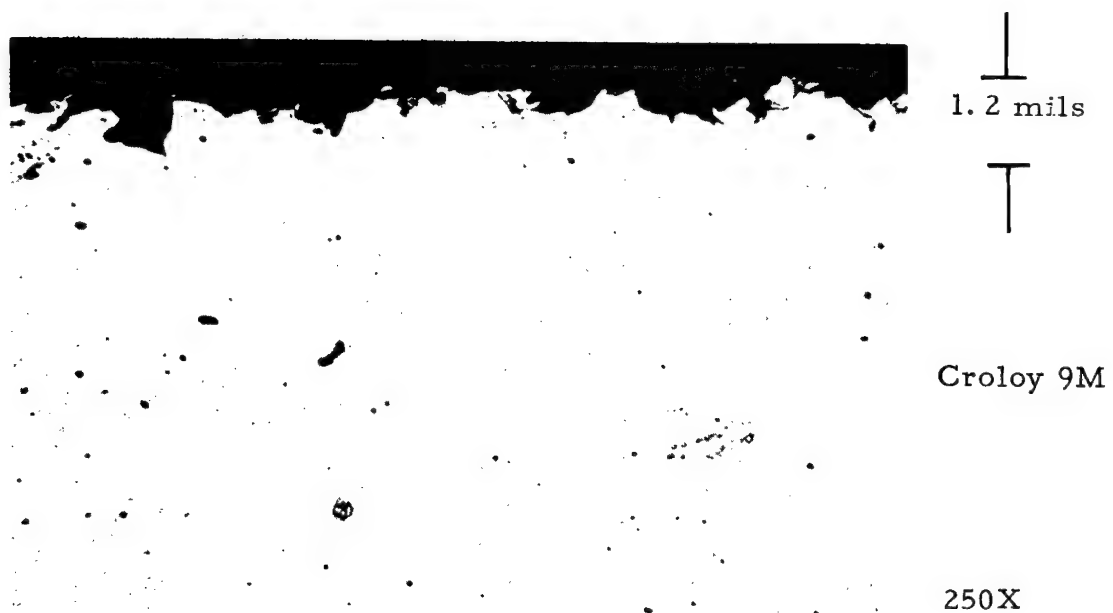
Figure 36. Intergranular Corrosion of Croloy 9M at Superheater Outlet.

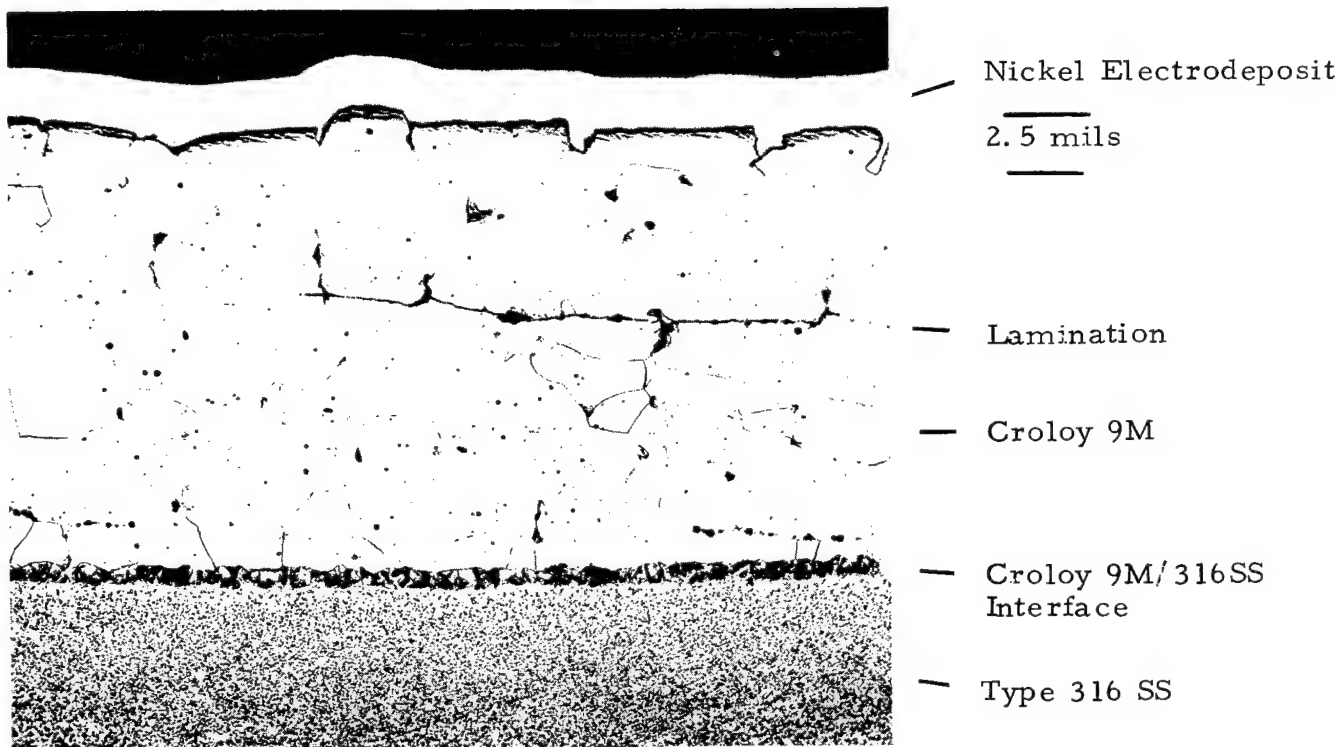
Figure 37. Intergranular Corrosion of Superheater Wall.

The microstructural change of the Croloy 9M in the superheater outlet section of this loop is clearly displayed in the photomicrograph of Figure 37. The normal grain structure of this ferritic steel has been replaced by an extremely low carbon, coarse grain ferrite. Apparently, long time elevated temperature exposure with intimate contact to Type 316 SS promoted the migration of carbon from the Croloy 9M to the austenitic stainless steel, accompanied by grain coarsening of the ferritic steel. The loss of carbon by the Croloy 9M did not change its original hardness ($R_B 85-96$) significantly. The acquisition of carbon by the Type 316 SS cladding material was manifested by a profusion of carbides (Figure 37) and an appreciable change in hardness, $R_B 96$ to $R_C 29$. The electron beam microanalysis of this section of tubing revealed extensive molybdenum and chromium-rich precipitates in the Type 316 SS, which are probably carbides. The electron beam microanalysis also revealed a diffusion zone at the Type 316 SS—Croloy 9M interface of 1.7 to 2.2 mils in thickness (see Figures 54 and 55). This diffusion zone is also displayed in the photomicrograph of Figure 37. This extensive diffusion zone in the superheater outlet section (operated at $1405 \pm 10^\circ\text{F}$) is compared with that observed in the boiler mid-section (operated at 1142°F and displayed in the photomicrograph of Figure 32). The diffusion zone in this lower-temperature region of the loop was found to be less than 0.3 mil in thickness, as revealed by the electron beam microanalysis (see Figures 56 and 57). The observed gross carbon diffusion and metallurgical structural changes of the Type 316 SS—Croloy 9M tubing in the $1405 \pm 10^\circ\text{F}$ temperature region is, of course, attributed to the excessive temperature.

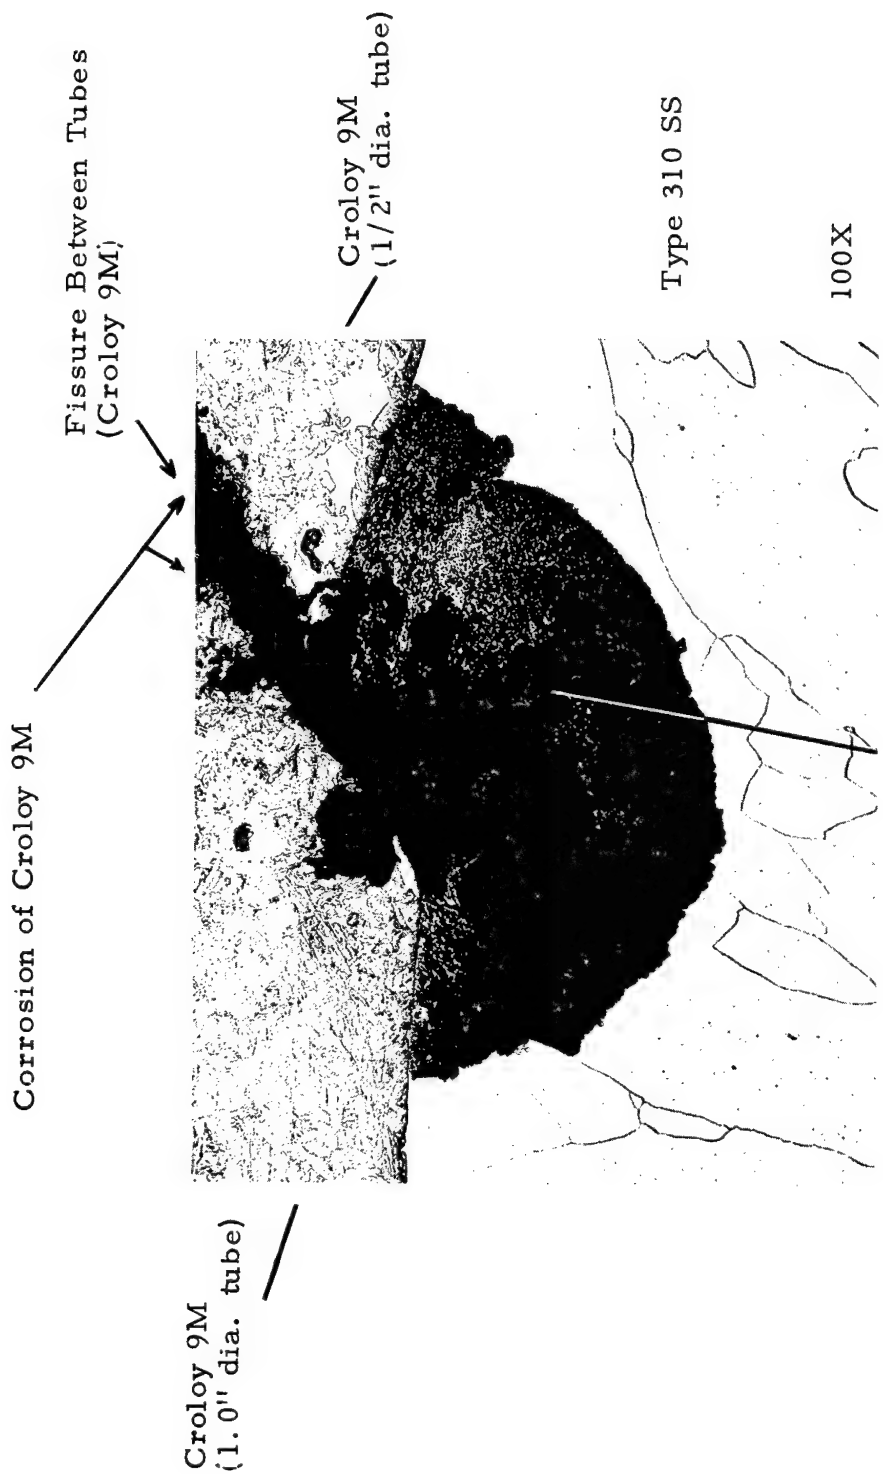
Figure 38. Leached Layer Corrosion of Type 310 SS Weld Metal and Croloy 9M at Weldment of 1/2 Inch Diameter Croloy 9M Tube to 1.0 Inch Diameter Duplex Tube (Croloy 9M/316 SS) in Boiler Section. Operating Temperature—1070°F. Etchant - Carapella.

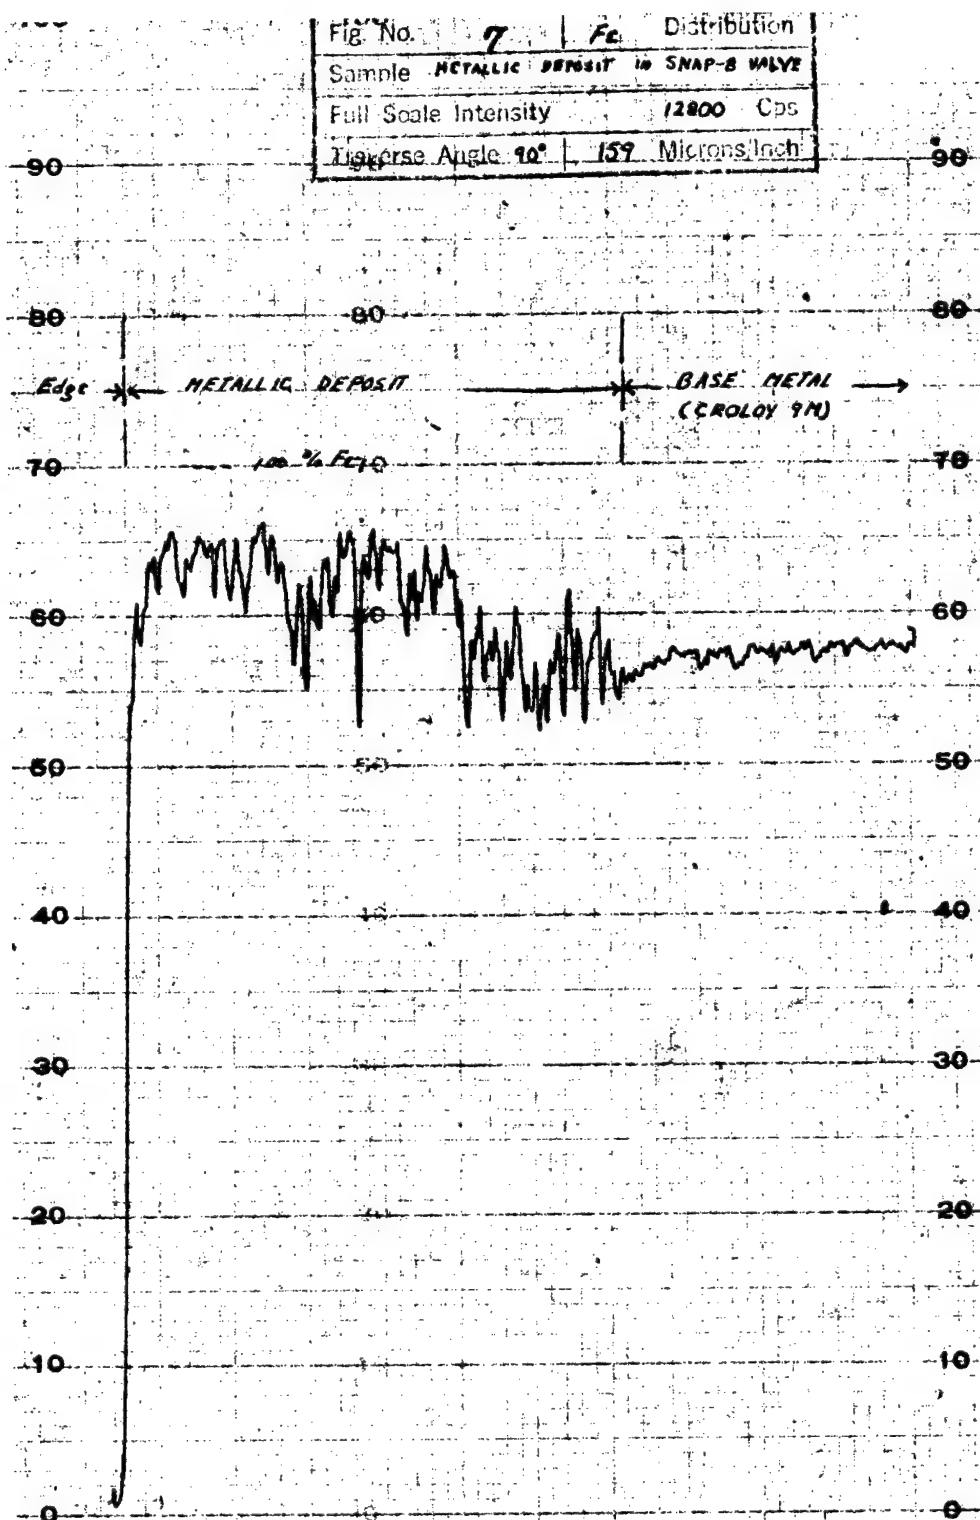
The iron, chromium, and molybdenum distributions in the deposit are shown in Figures 47, 48, and 49, respectively. It is seen here that the deposit is iron-rich and chromium- and molybdenum-poor. The chromium shows a small gradient in the vicinity of the deposit-base metal interface but rapidly falls to less than one percent. The molybdenum content drops abruptly to approximately zero percent at the deposit-base metal interface. The iron concentration rises to roughly 90 to 95 percent. Chromium-rich phases are present in both the deposit

Figure 47. Distribution of Iron in the Deposit Found in the Croloy 9M Throttling Valve.

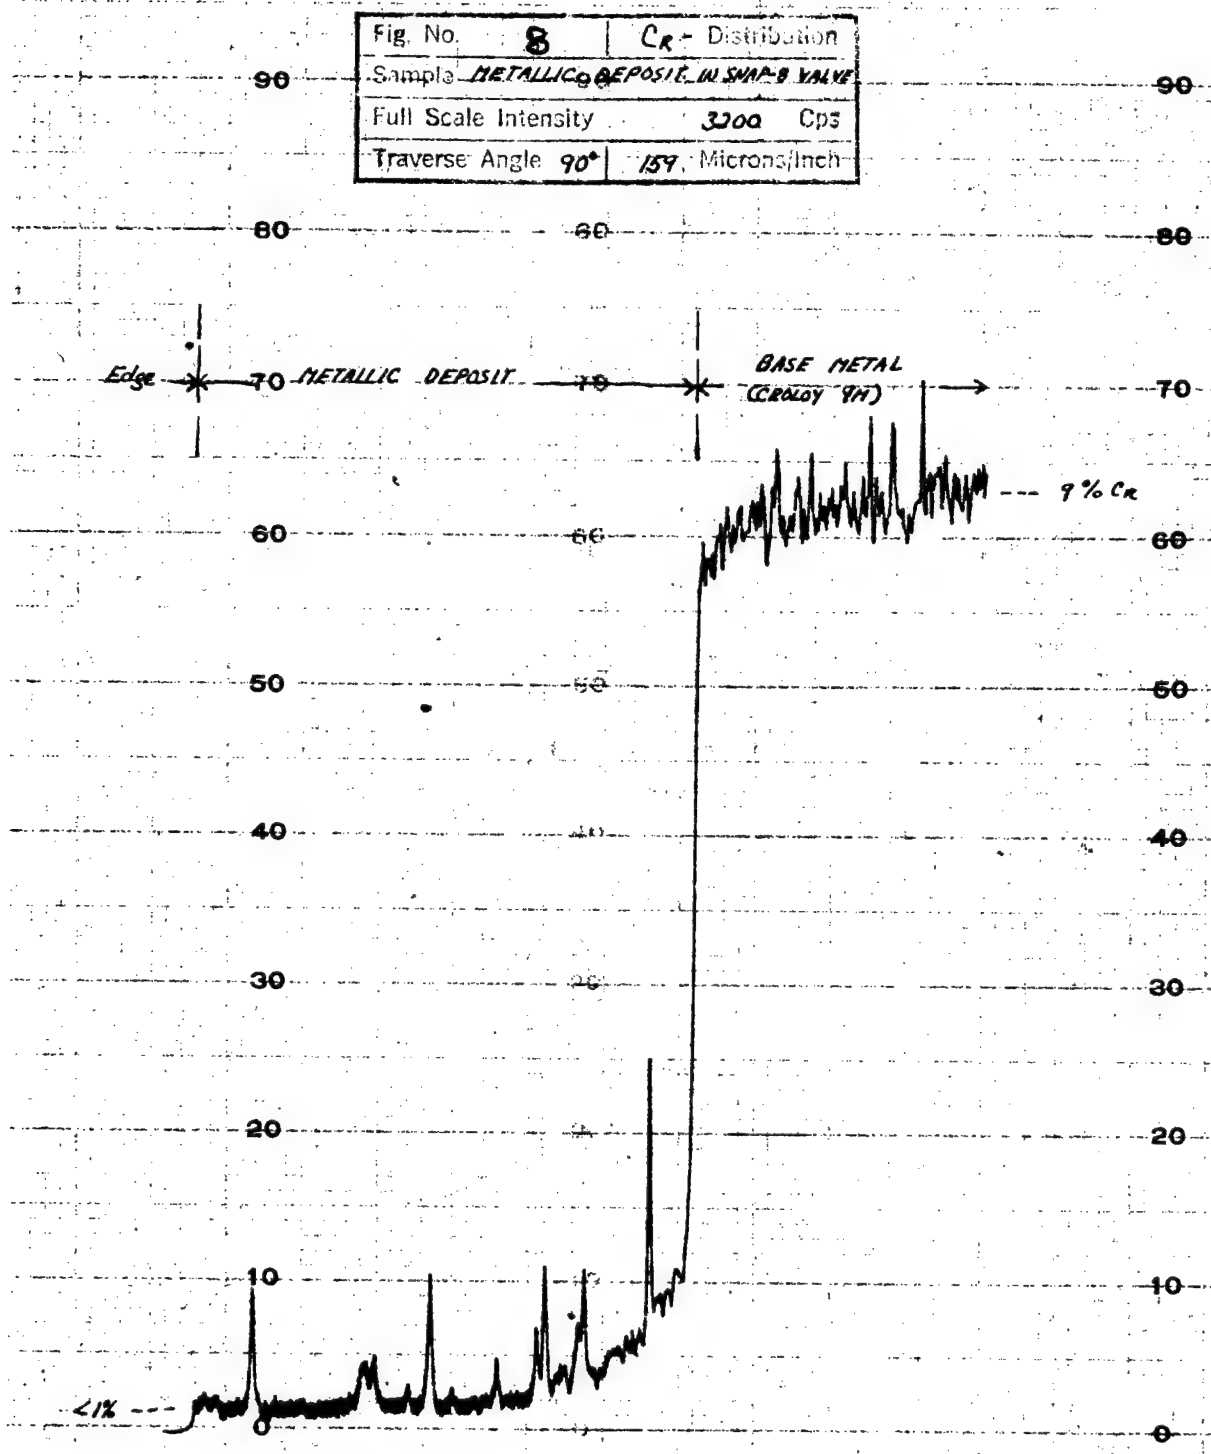
Figure 48. Distribution of Chromium in the Deposit Found in the Croloy 9M Throttling Valve.

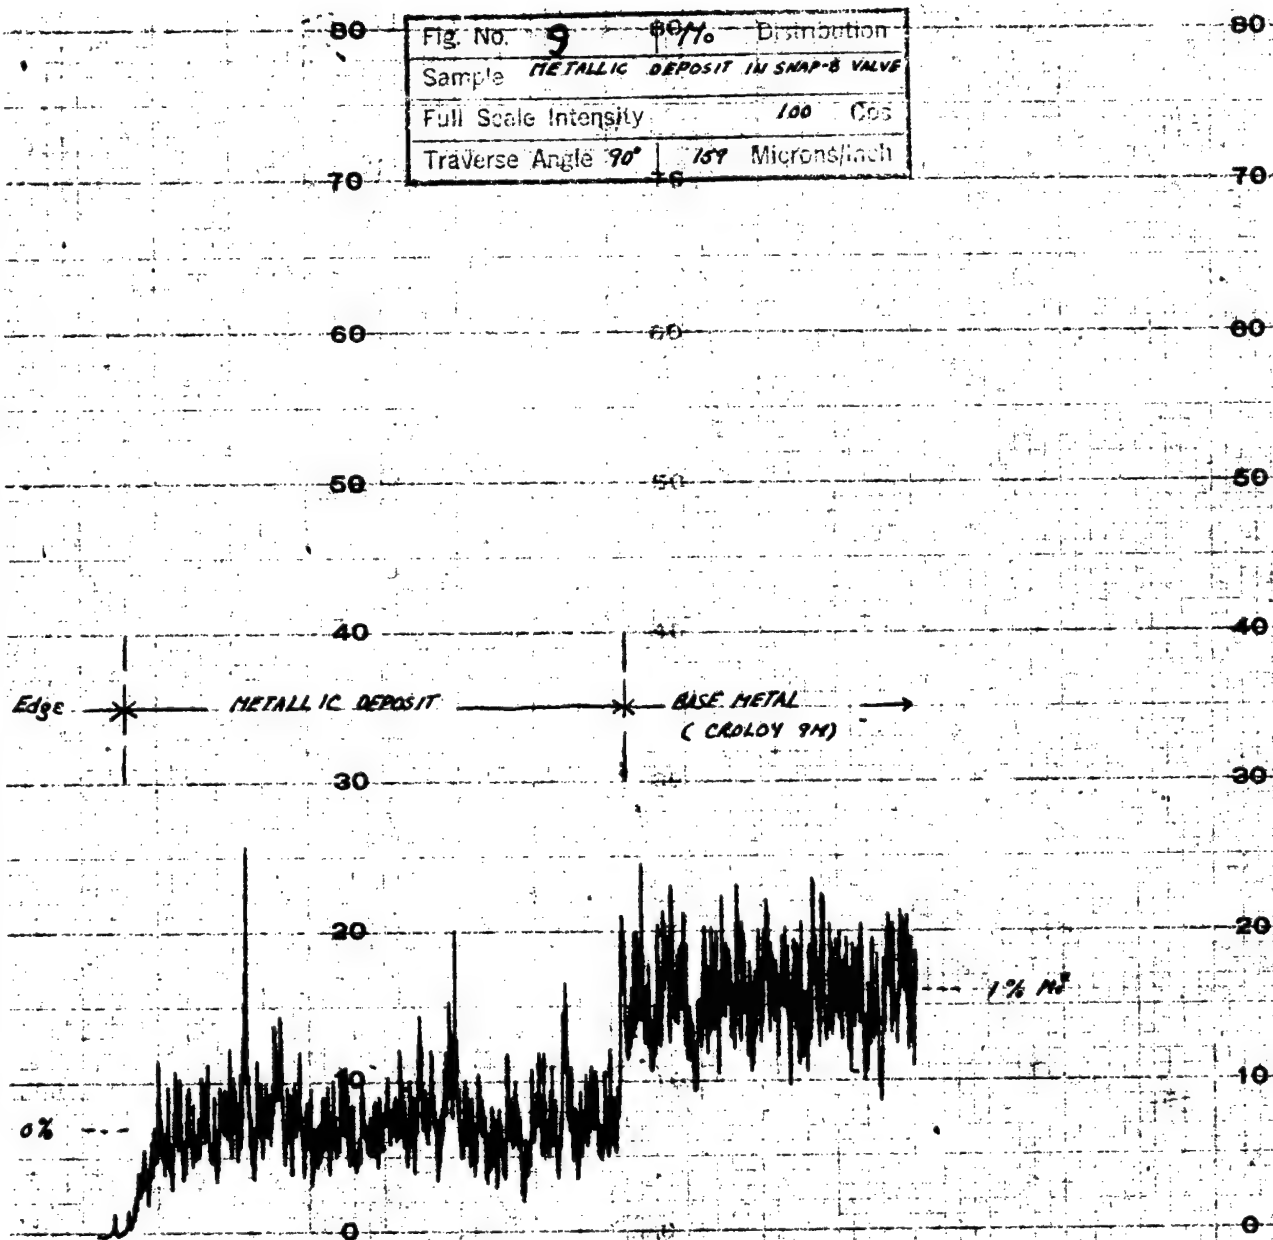
Figure 49. Distribution of Molybdenum in the Deposit Found in the Croloy 9M Throttling Valve.

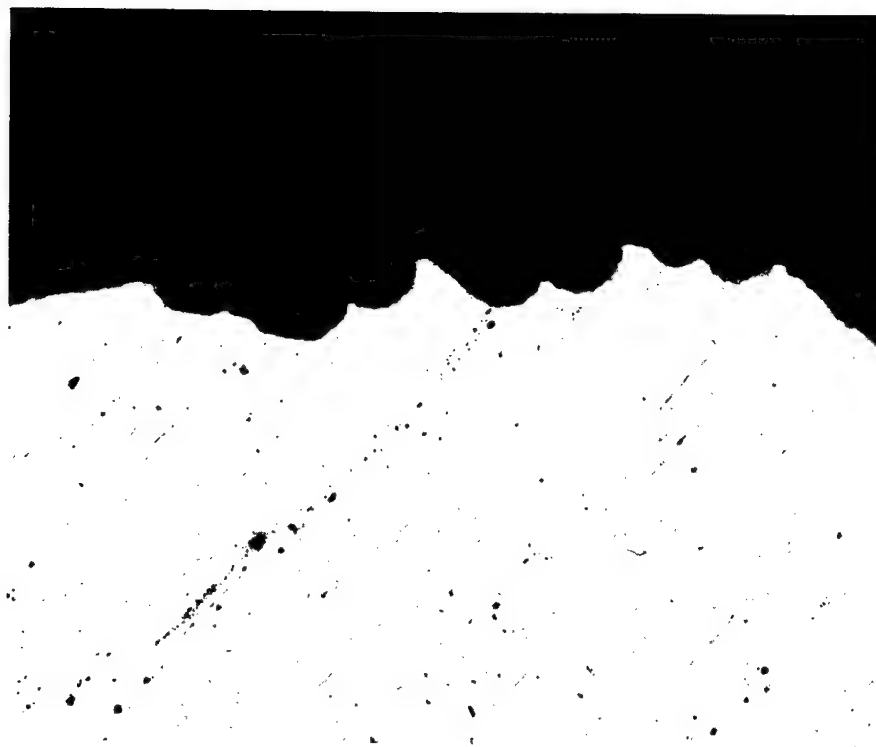
Deposition and corrosive and/or erosive attack were observed, after 448 hours of loop operation, in a Croloy 9M throttling valve located at the superheater outlet.

Figure 51. Attack on the Stem of the Croloy 9M Throttling Valve.

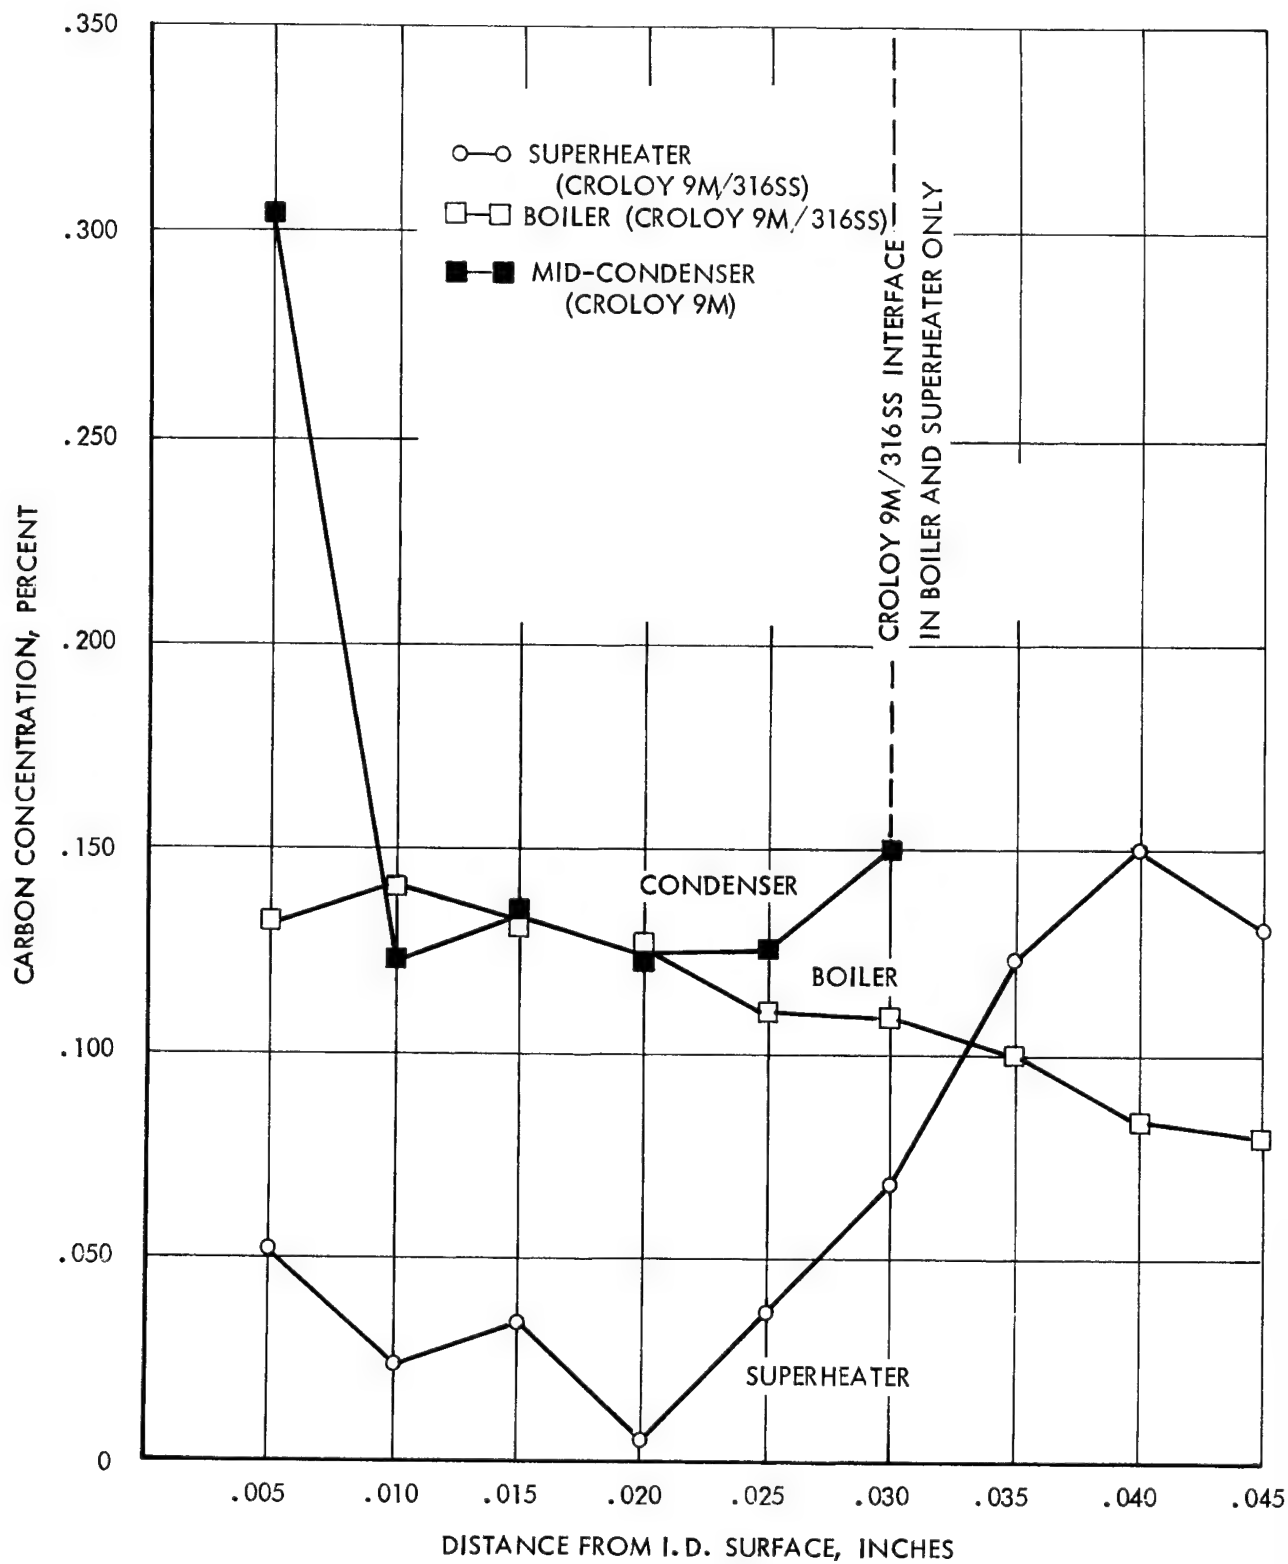
Figure 53. Carbon Content of Loop Wall at Various Distances from the I.D. Surface.

It is apparent from these carbon analyses that the Type 316 SS—Croloy 9M composite tubing is subject to metallurgical changes because of carbon diffusion at temperatures above 1200°F. Furthermore, it is indicated from these results that carbon is lost by the Croloy 9M by diffusion to the Type 316 SS cladding.
